PBY Catalina

Walk Around

By William Scarborough

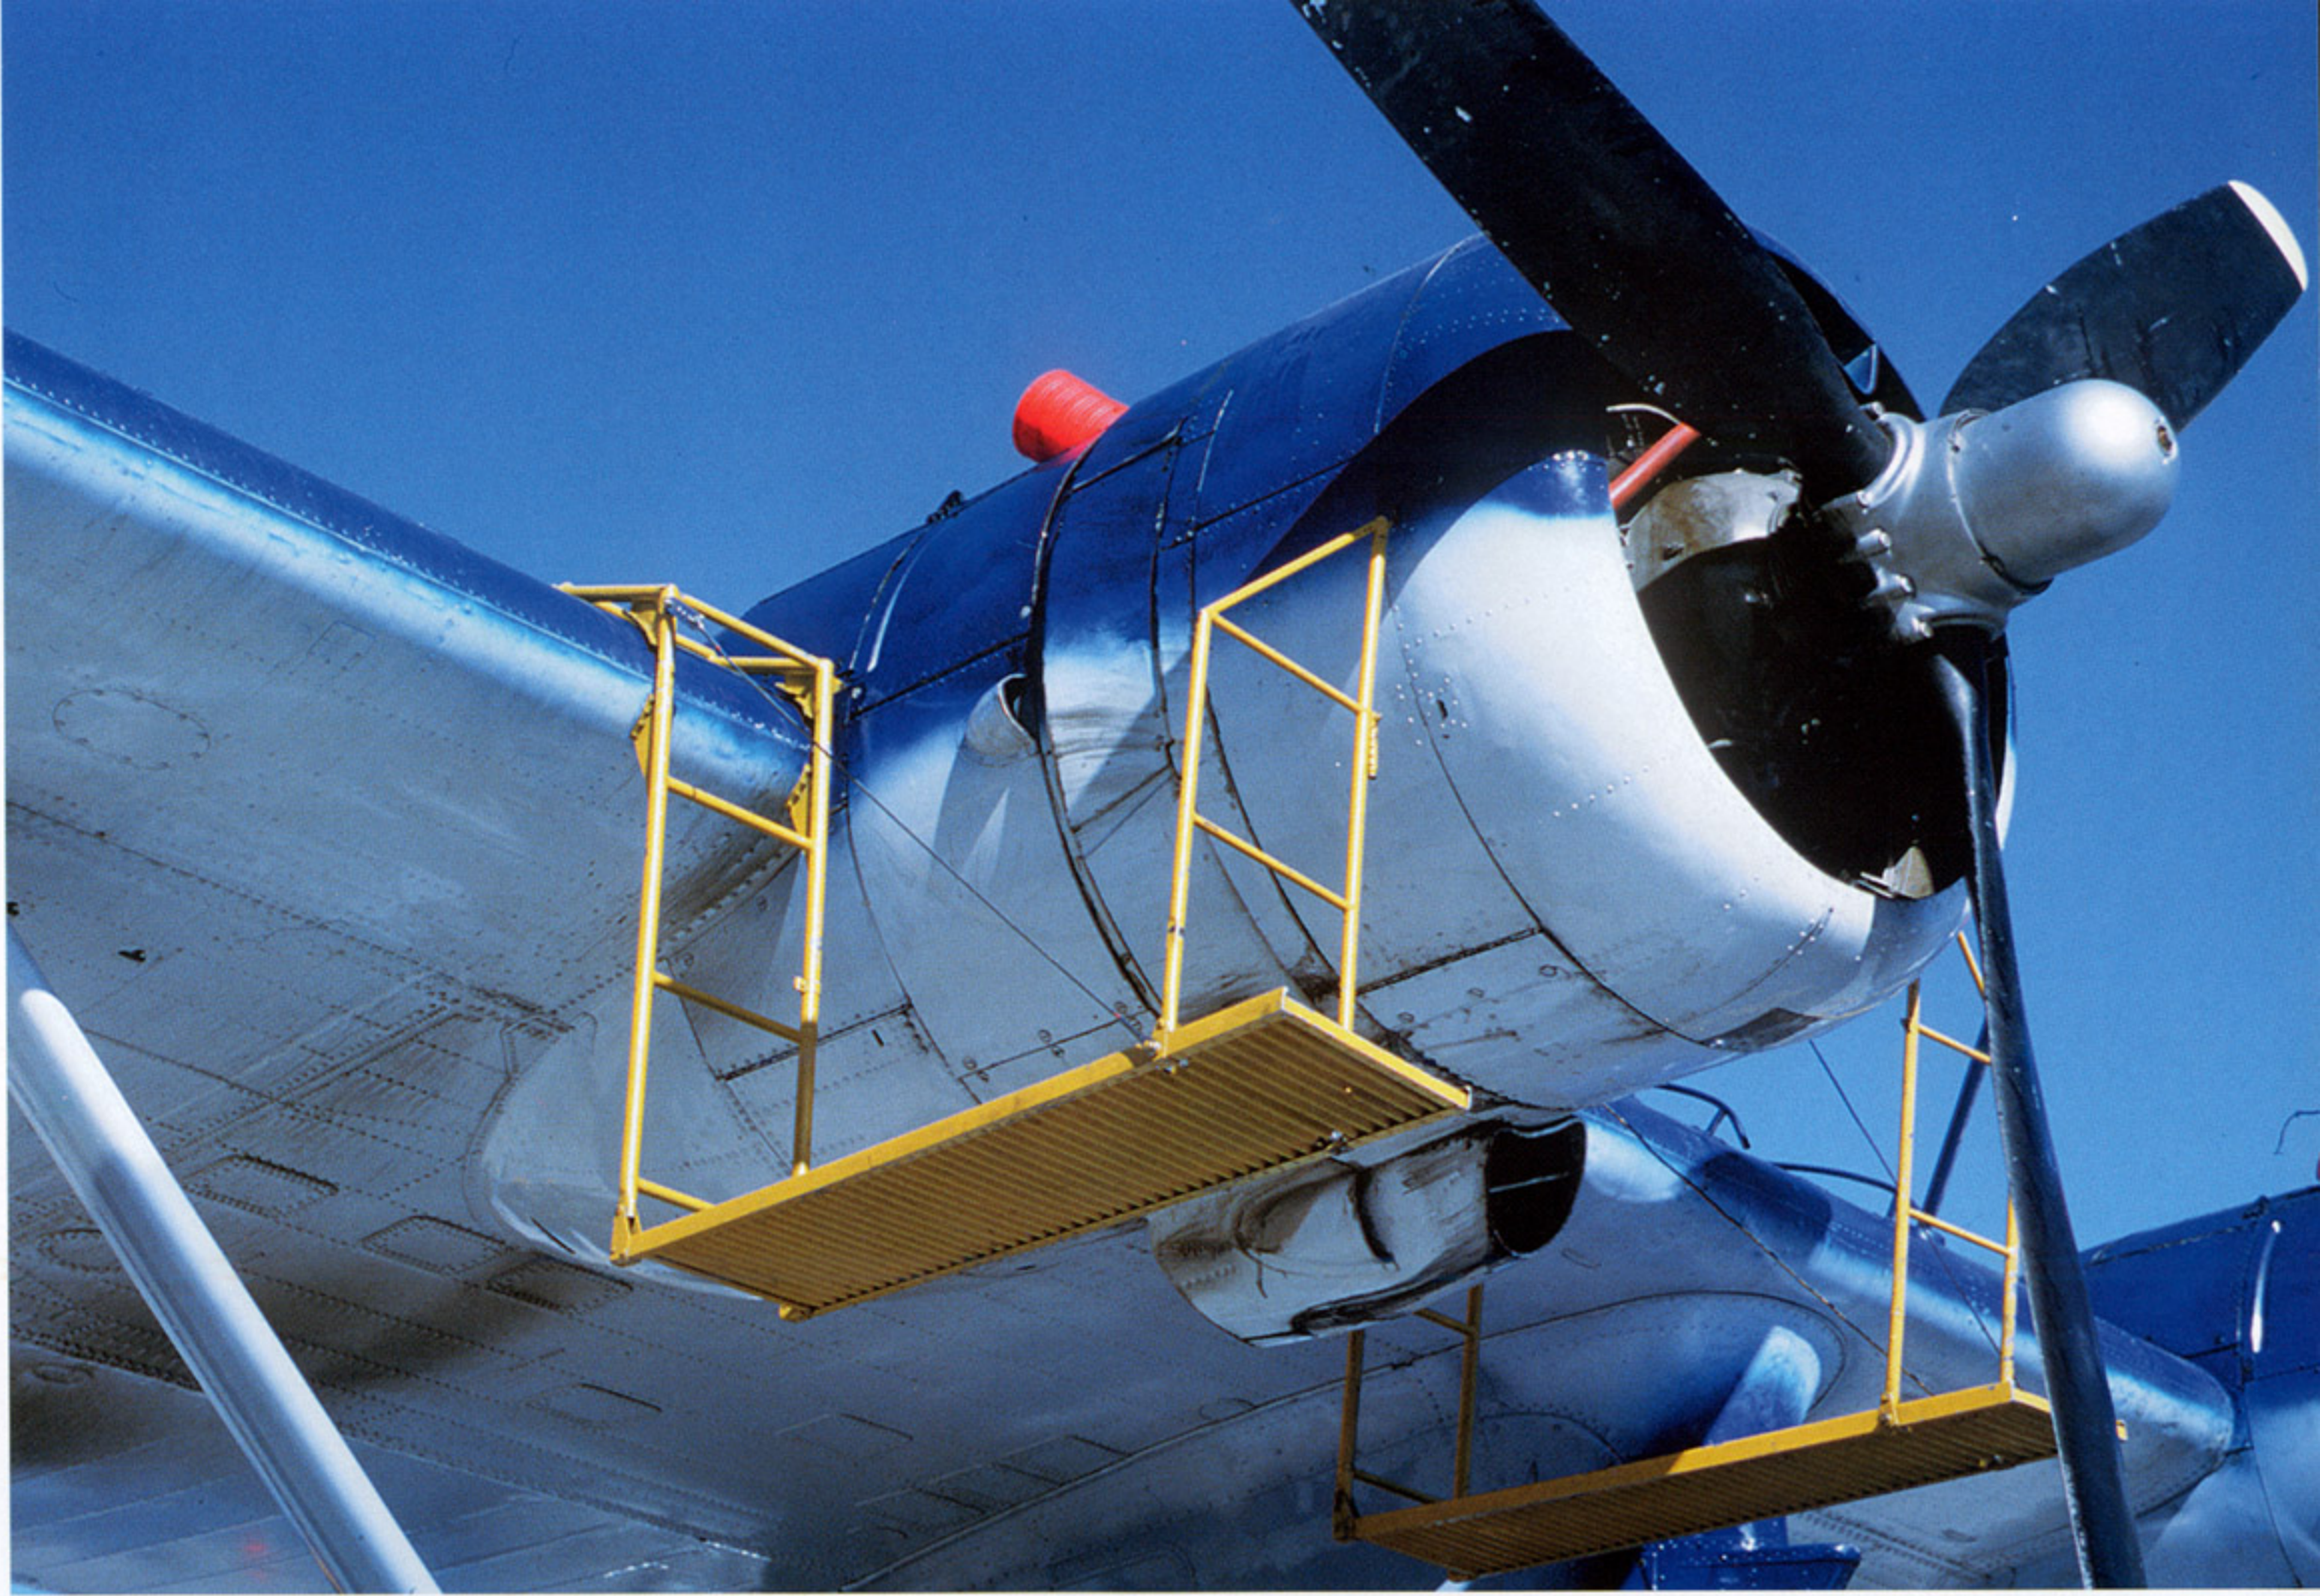
This PBV-6A Catalina is owned by the Confederate Air Force and is powered by Pratt & Whitney R-1830-92 air-cooled radial engines driving twelve foot, three blade Hamilton-Standard constant-speed propellers. The work stands attached into sockets above the wing and in the forward portion of the cowling, allowing maintenance personnel access to the engine. The work stands were normally carried aboard service PBVs stowed in the bunk compartment. (Mark Aldrich)

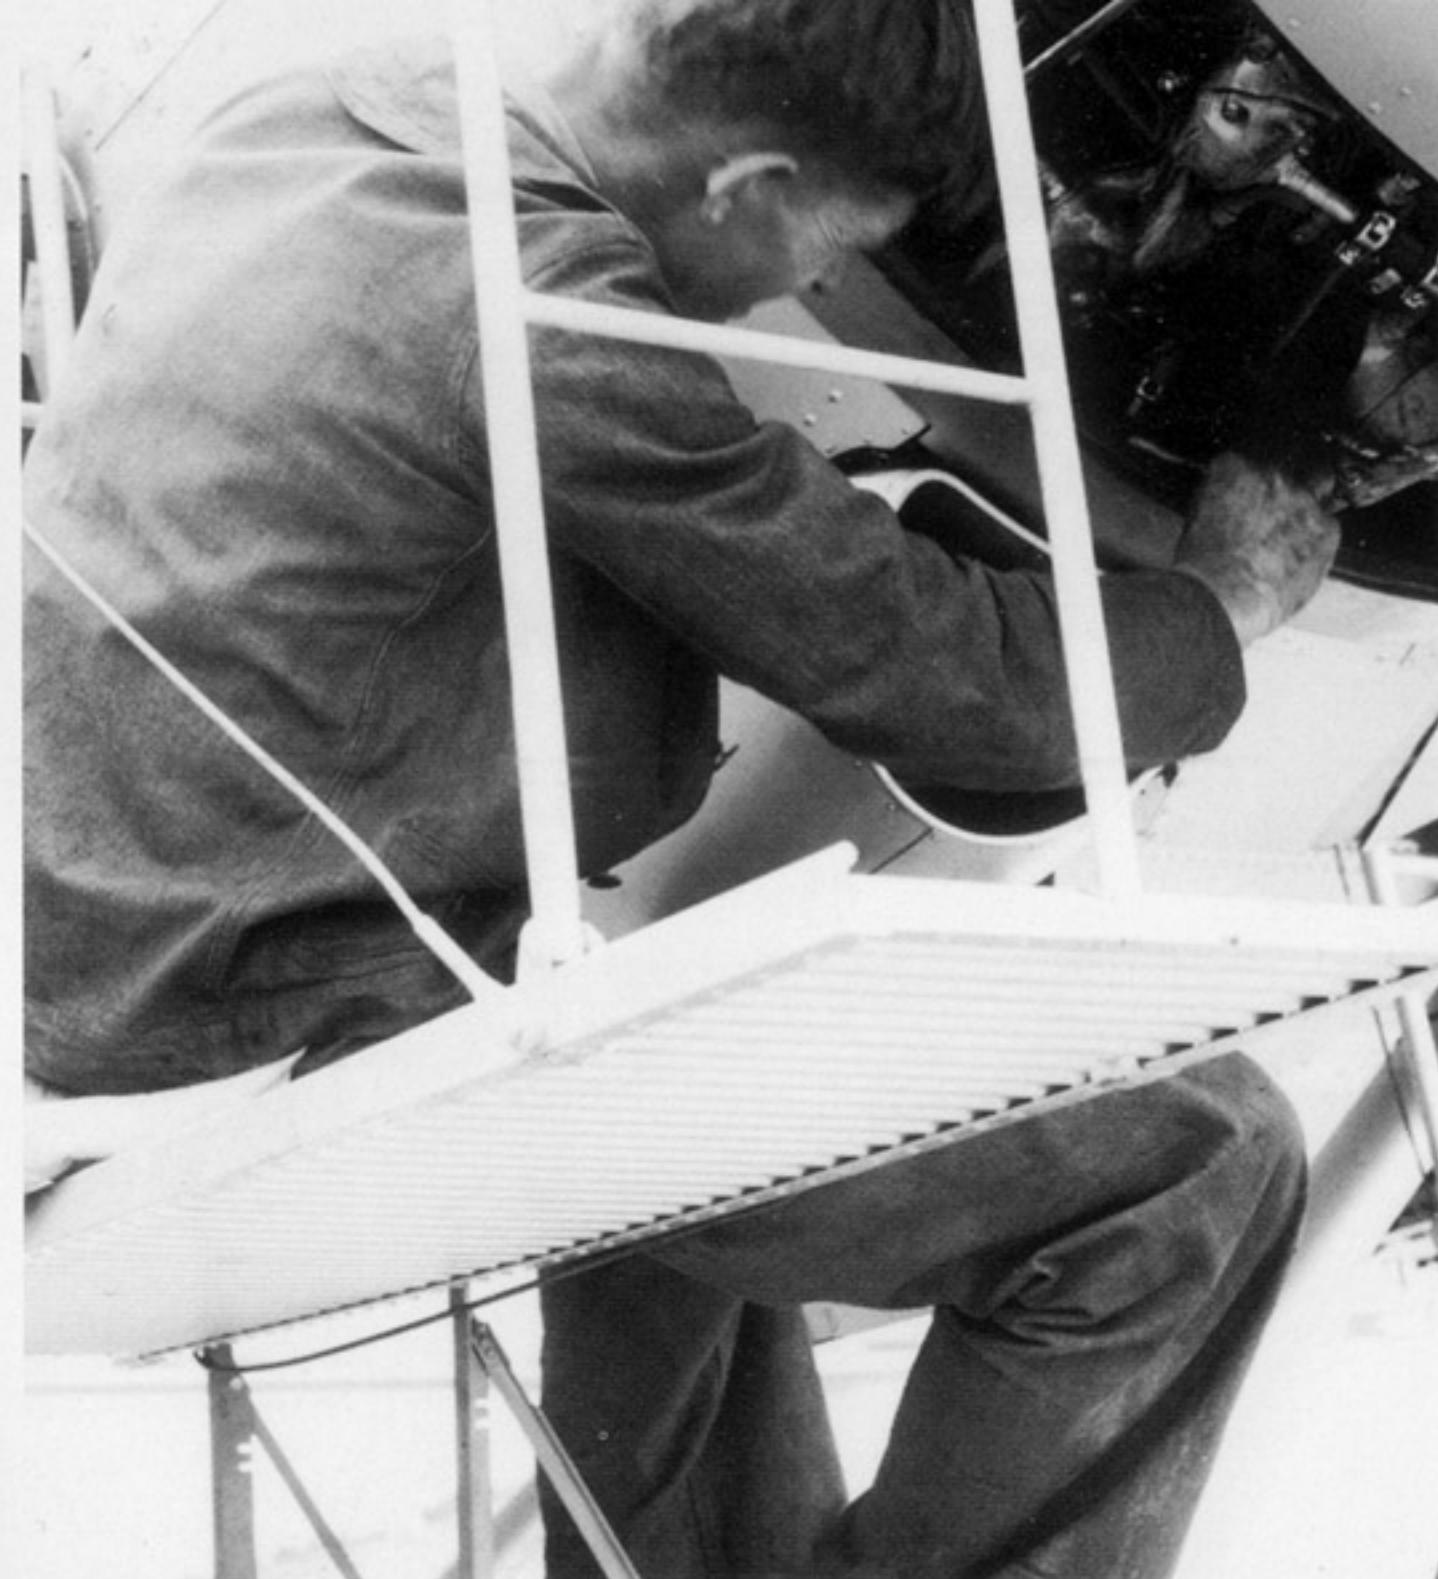
(Above) Aviation Machinist Mate 1c E. F. Dyer used the portable work stands that were supplied with each aircraft to work on the engine. When working at a buoy, a tarpaulin was spread under the nacelle between the work stands to catch any dropped parts or tools. (WES)

(Left) E.F. (Pappy) Dyer, AMM1, USN, was the Plane Captain (Crew Chief) of 52-P-9, a PBV-5 (BuNo 2293) assigned to Patrol Squadron Fifty-Two (VP-52). He uses a socket set and portable work stand to change the engine's spark plugs at Naval Air Station Norfolk, Virginia, during February or March of 1941. The author was a NAP, (enlisted pilot) assigned to Dyer's crew. The wire behind Dyer was a support wire that ran from the top to the bottom of each work stand. (WES)

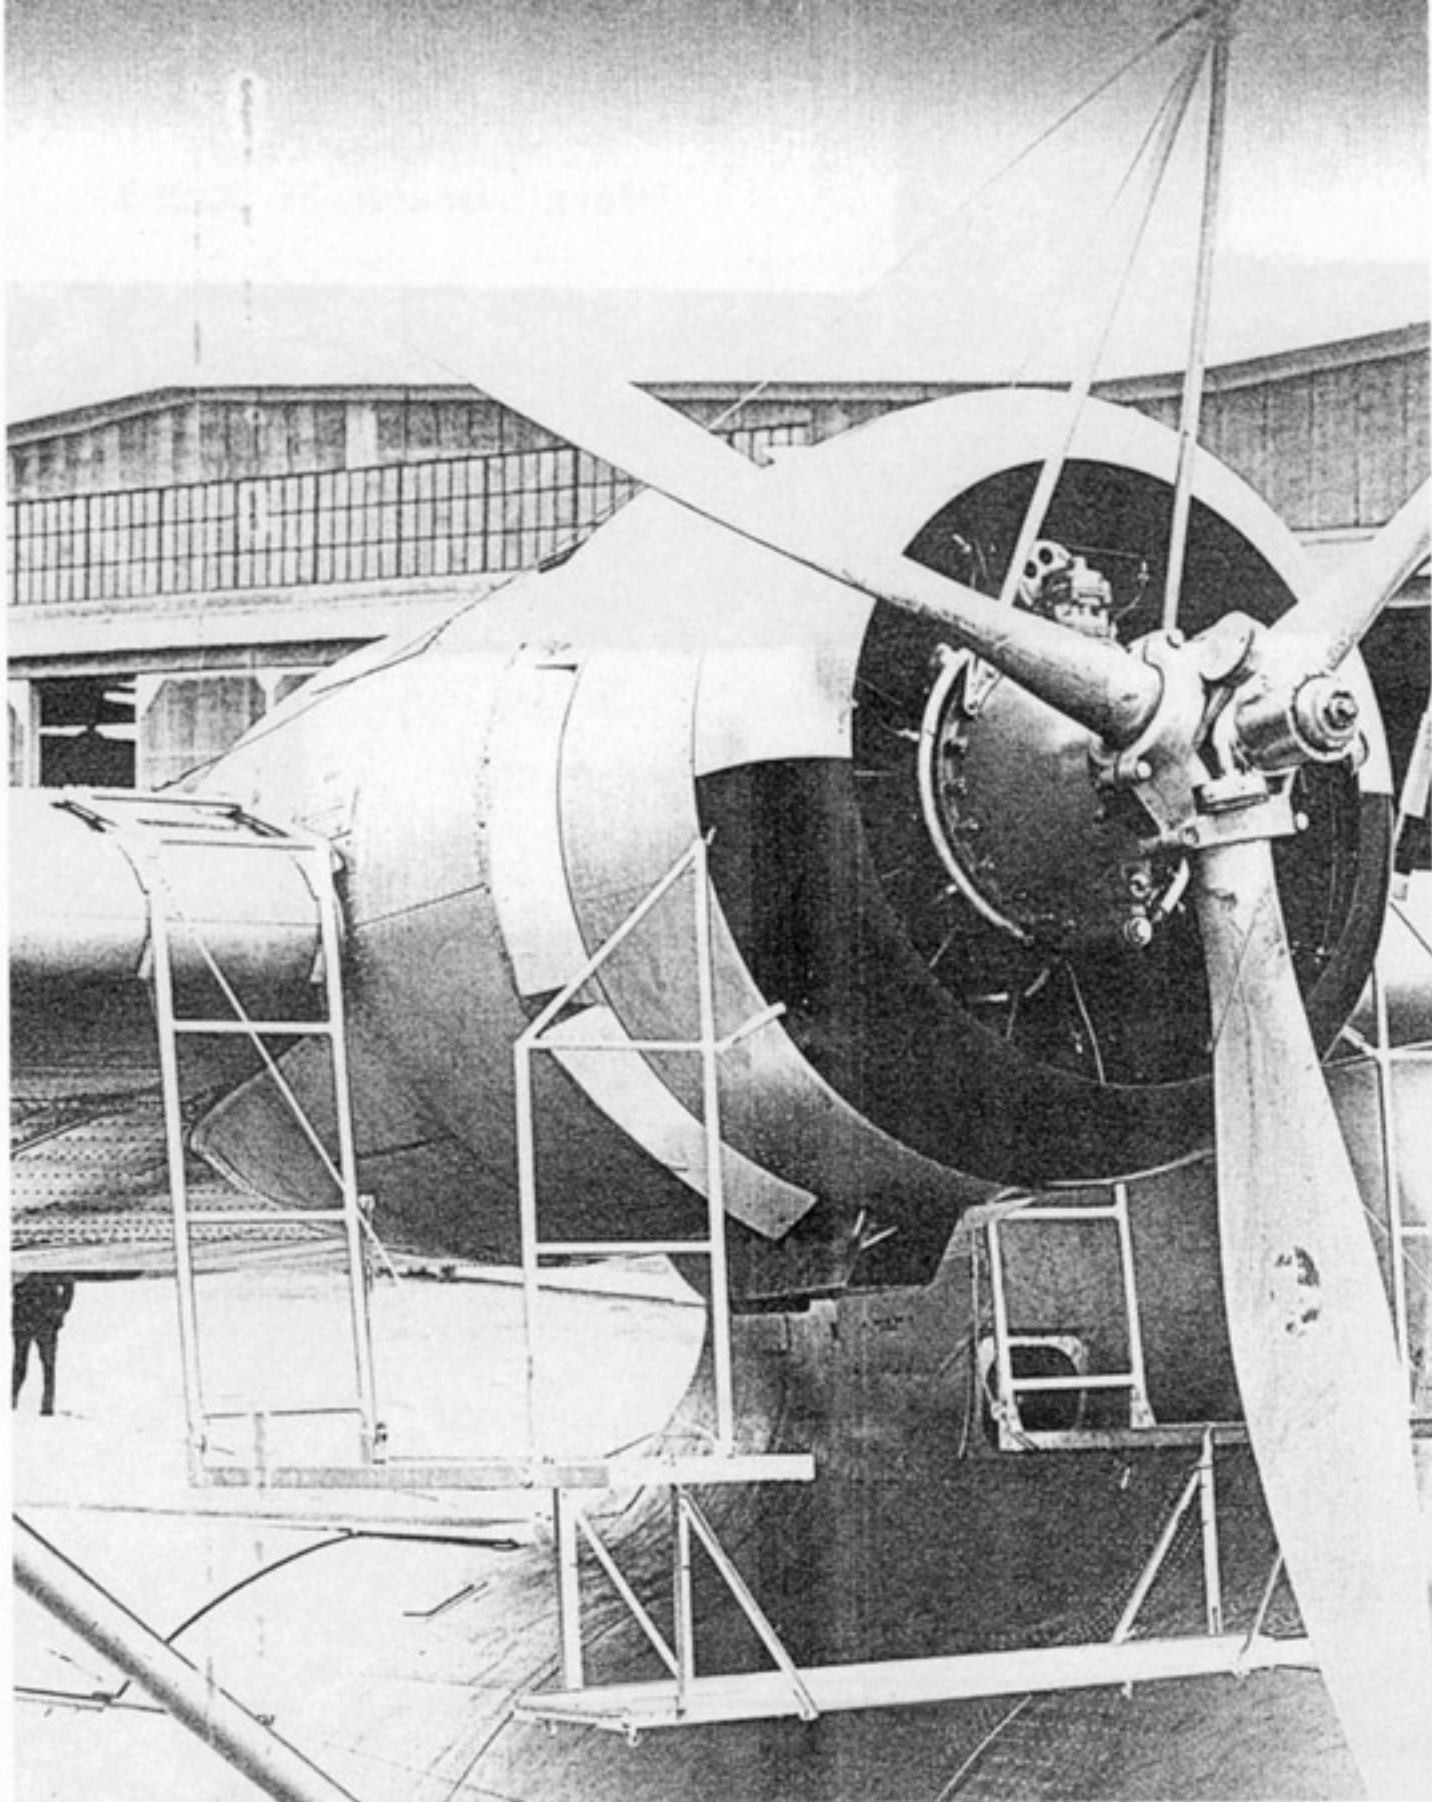
PBY engine work stands in place on each side of the engine nacelle. The V strut above the propeller was a portable propeller hoist used to change propellers in the field. These, like the work stands, were the same for all PBY variants. (USN)

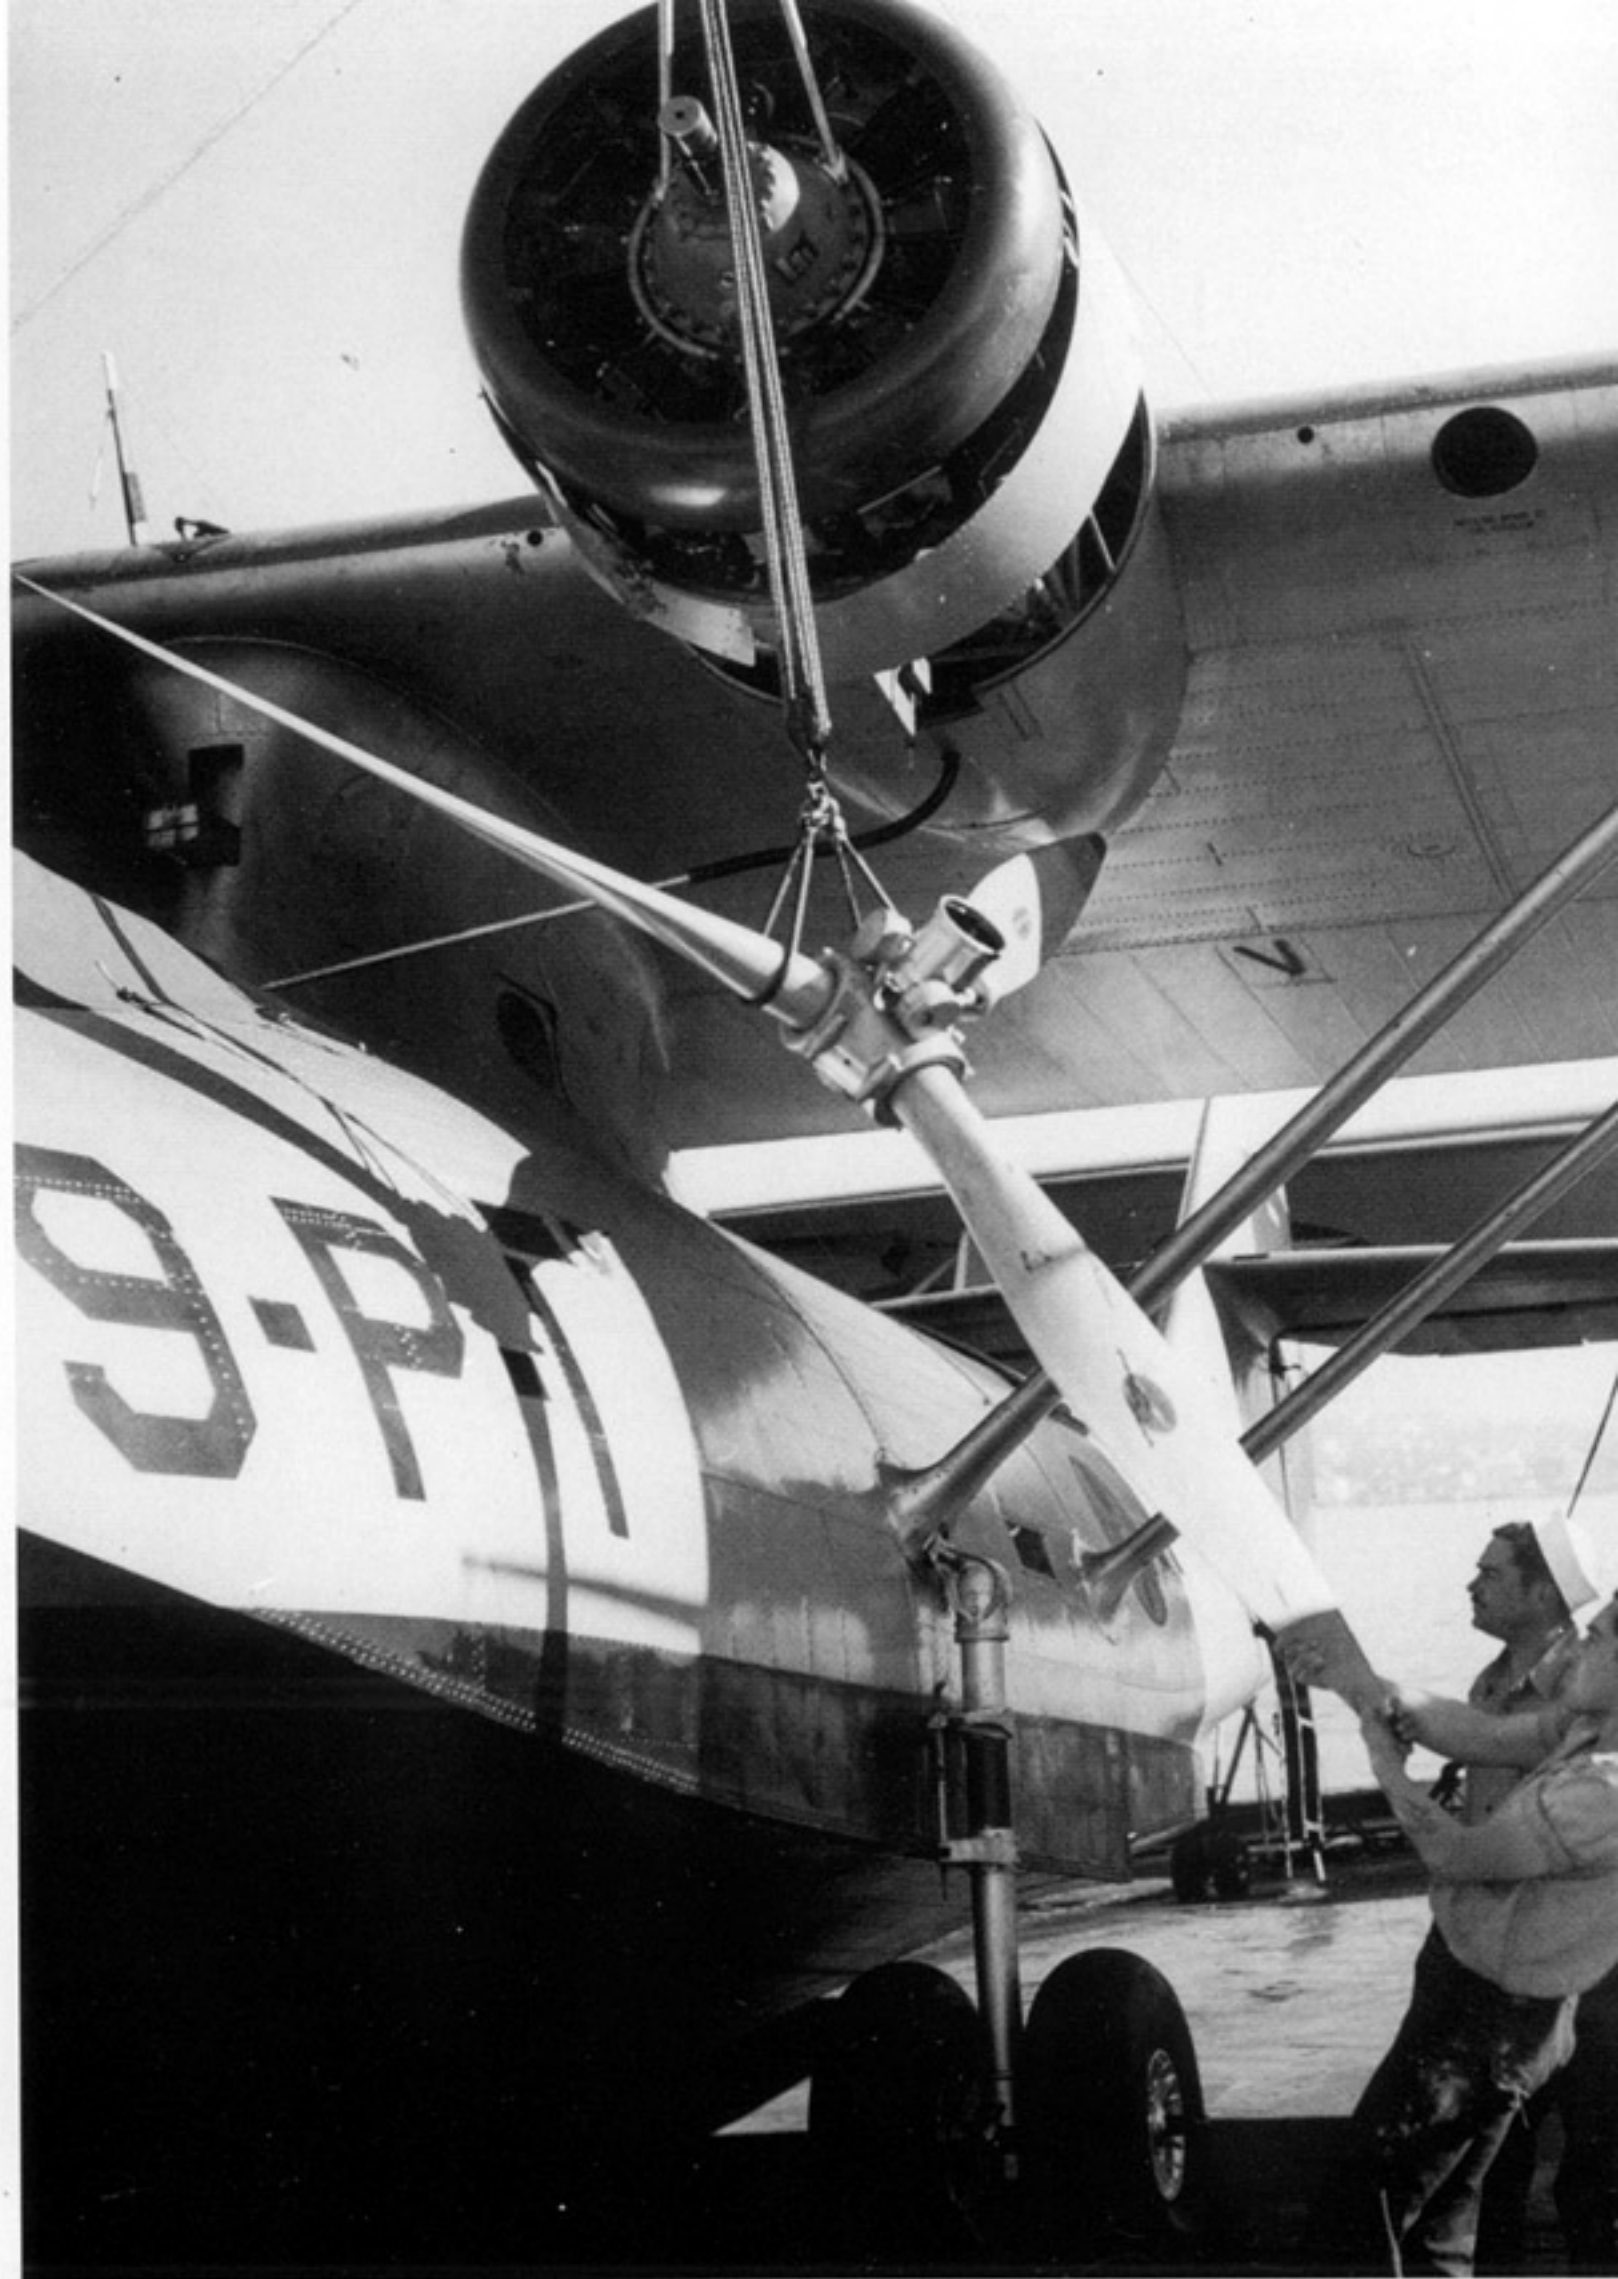
The wire support line was bolted to the upper and lower work stand vertical posts. This PBY has oil stains on the cowl flaps and under the engine nacelle, not an unusual sight on all PBYs. (Mark Aldrich)

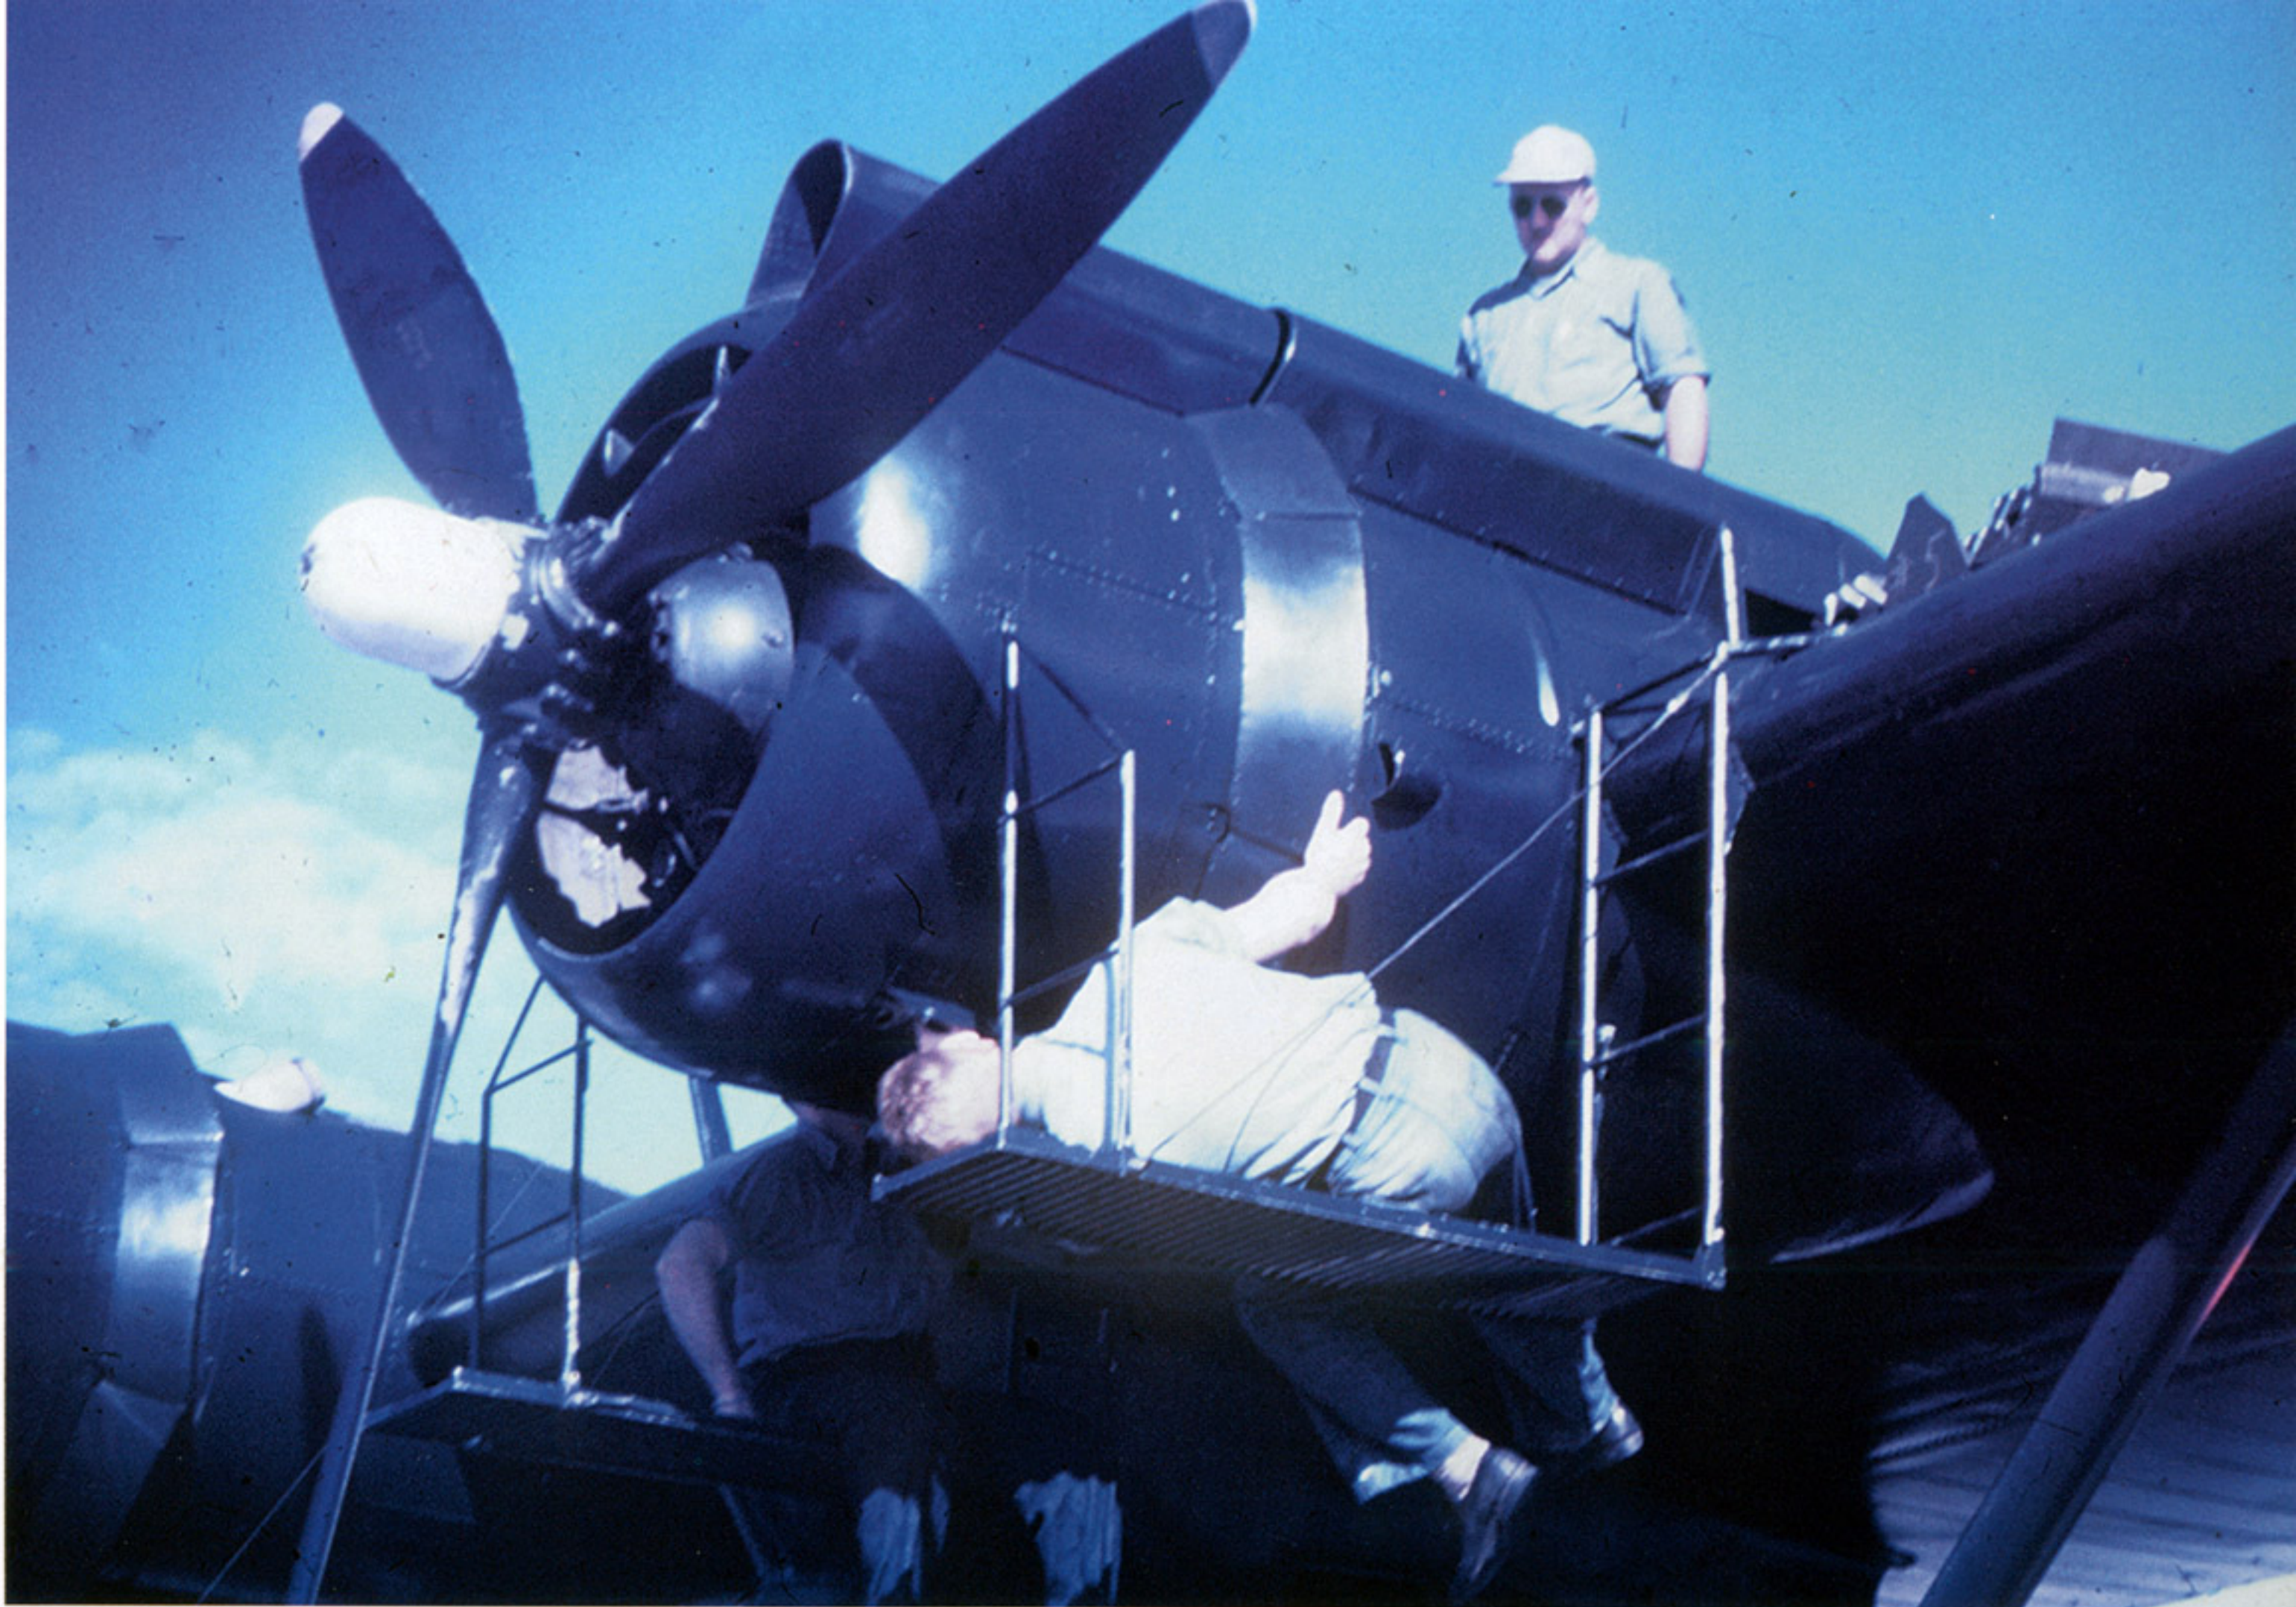
Maintenance personnel use portable work stands to check the engine of a PBX-5 equipped with a thermal wing deicing system shroud on the port engine exhaust. The cowl flaps are in the full open position. (Mark Aldrich)

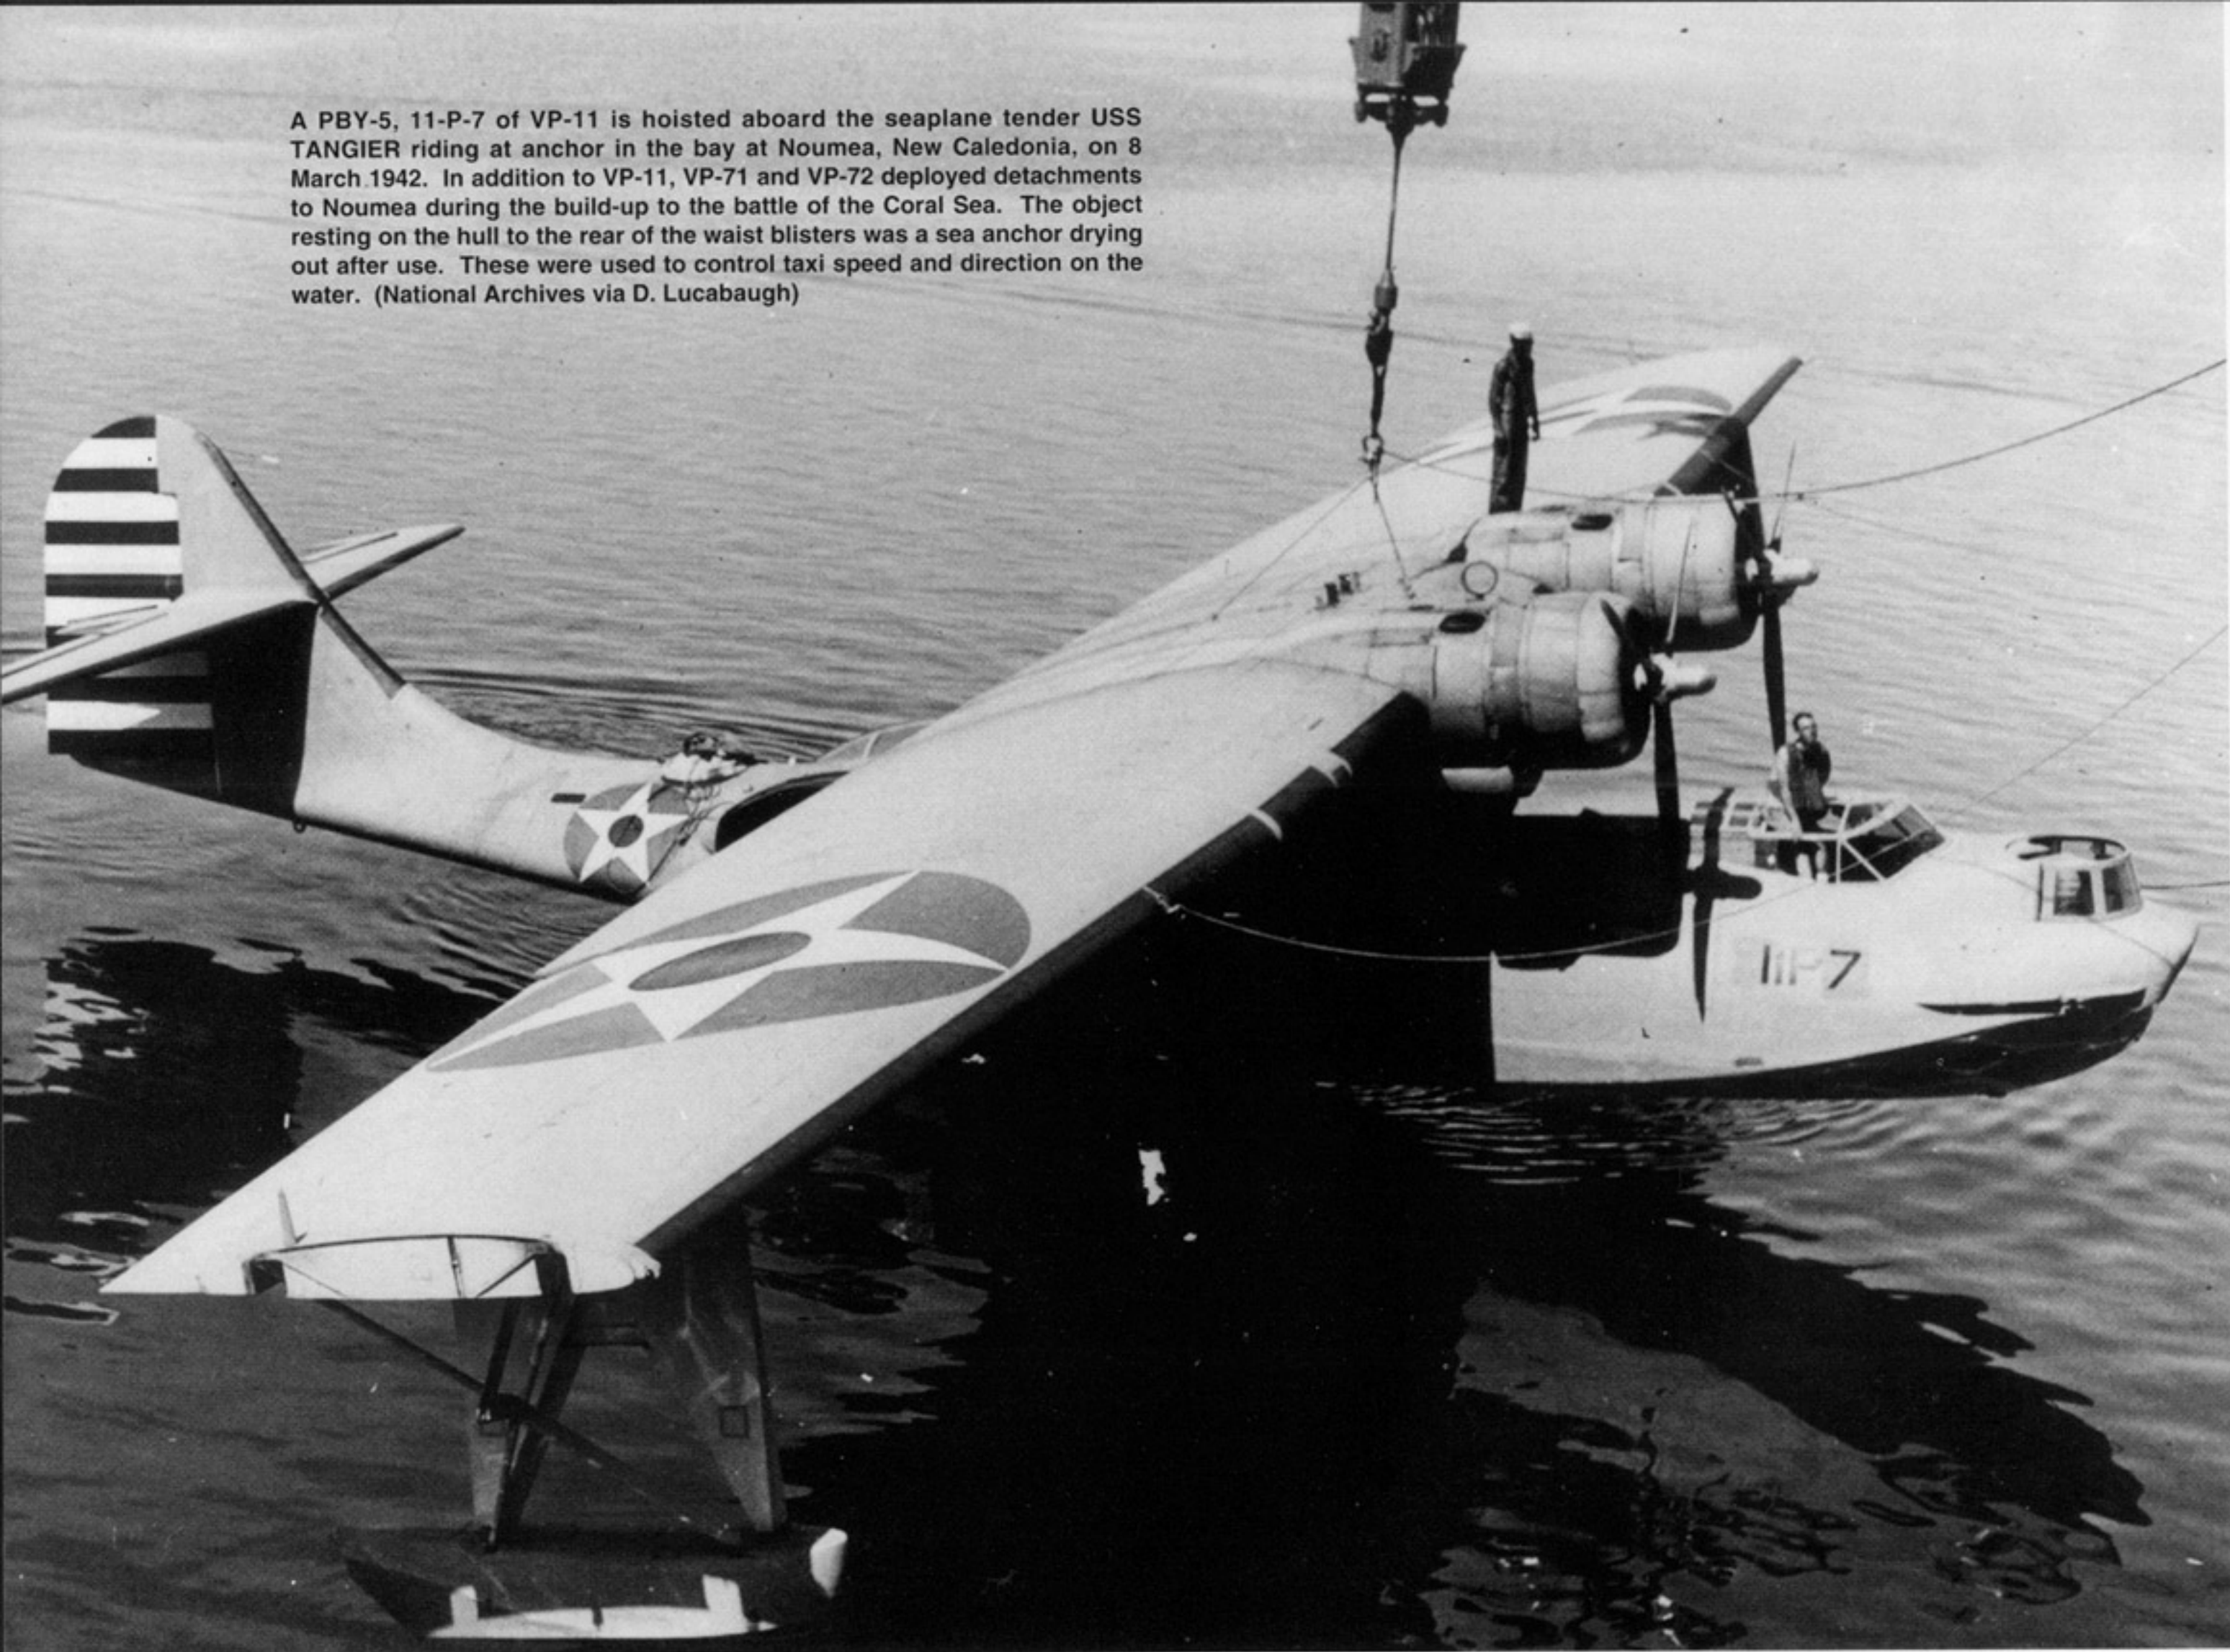
A PBY-5, 11-P-7 of VP-11 is hoisted aboard the seaplane tender USS TANGIER riding at anchor in the bay at Noumea, New Caledonia, on 8 March 1942. In addition to VP-11, VP-71 and VP-72 deployed detachments to Noumea during the build-up to the battle of the Coral Sea. The object resting on the hull to the rear of the waist blisters was a sea anchor drying out after use. These were used to control taxi speed and direction on the water. (National Archives via D. Lucabaugh)
